Entrapment of a Multipolar Mapping Catheter in a Mitral Valve Prosthesis

CASE IMAGE OLGU GÖRÜNTÜSÜ

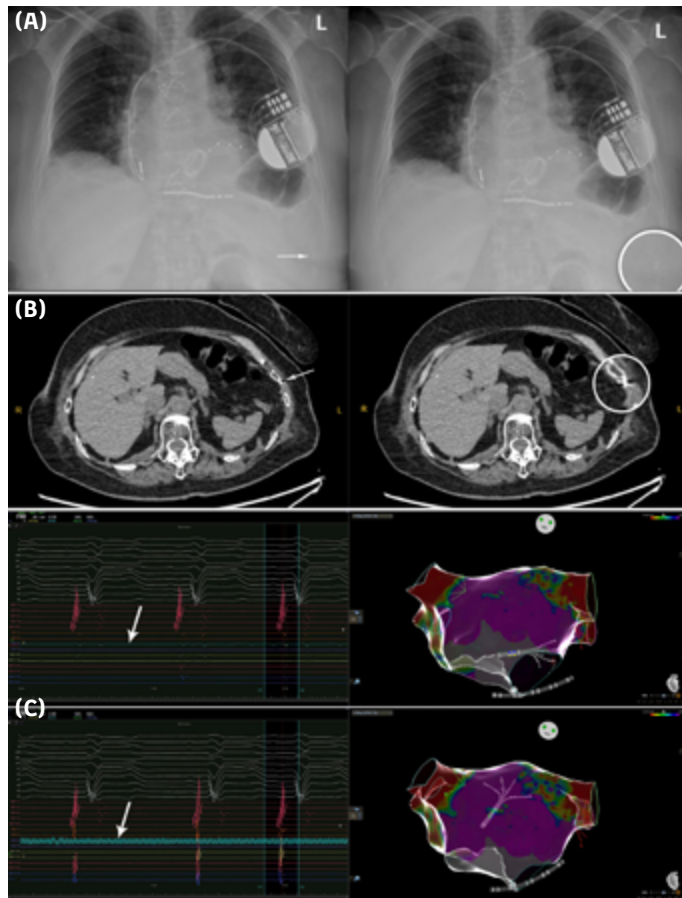
Figure 2. Teleradiograph showing the embolized segment (arrow) near the distal left rib cage in normal (left) and magnified (right) images (A). Computed tomography showing the embolized segment (arrow) in the distal portion of the intercostal artery in normal (left) and magnified (right) axial images. 3D mapping showing all five splines, with at least one located at the orifice of the mechanical valve and far-field atrial and ventricular signals on intracardiac electrograms (arrow) (upper). 3D mapping showing four splines in the left atrial cavity and continuous artifact recording in bipole 5-6 (arrow), with normal electrograms in the remaining electrodes (lower).
